## H180N2 Bearing Box TIT Axial Fan Components Fan Spindle Rust Resistance

H180N2 Bearing box spindle, fan spindle

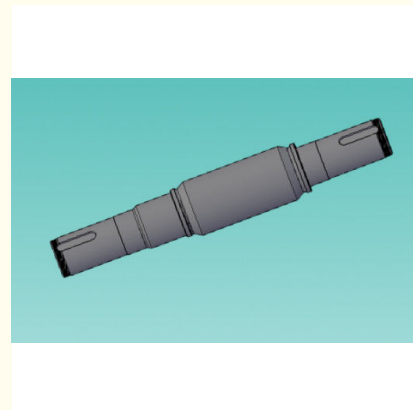
- Name: Main Shaft
- Model: 1TY0224
- Material: 42CrMo-5
- Weight : 350kg
- Total Length: 1537mm
- Applicable To: 180N2 Bearing Box
- Highlight: **TIT axial fan components,  
axial fan components fan spindle,  
Fan Spindle Rust Resistance**
