## H200N2 TIT Axial Fan Parts Fan Spindle 42CrMo-5 Material 1750mm Length

H200N2 Bearing box spindle, fan spindle

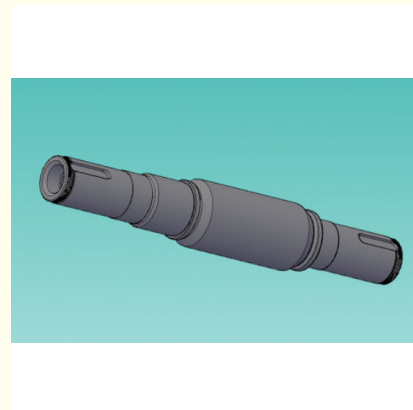
- Name: Main Shaft
- Model: 1TY0225
- Material: 42CrMo-5
- Weight : 475kg
- Total Length: 1750mm
- Applicable To: 200N2 Bearing Box
- Highlight: **Axial Fan Parts Fan Spindle,  
Fan Spindle 42CrMo-5,  
axial fan accessories Fan Spindle**
